Manhole Inspection Summary

Manhole # S39A__009MH

Insp Date: **11/29/07 9:15 AM**

Location Address: **forrest st**

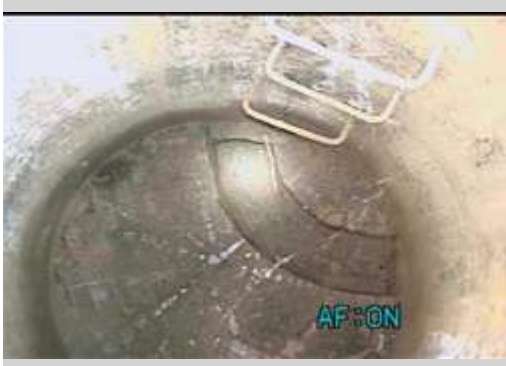
Top View

new top view

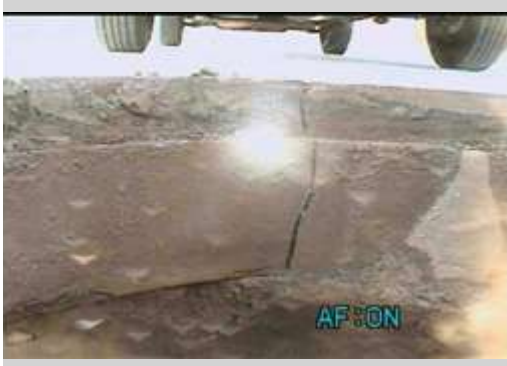
Defect 2

Frame Offset: **3** (in.) Condition: ☐ Sound ☒ **Cracked** ☐ Leaks

Cracked frame

additional view of crack in frame

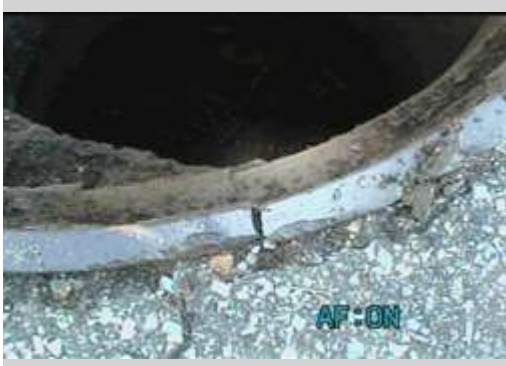
Defect 1

Comments **was first done on 11/29/07 got the bad crack in the frame & re did top view so pipe at 12 is at 12oclock**

top view of crack in frame

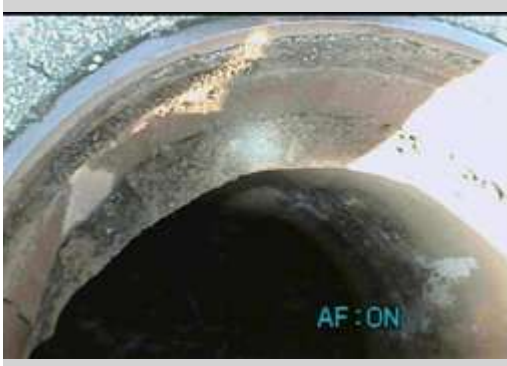
offset

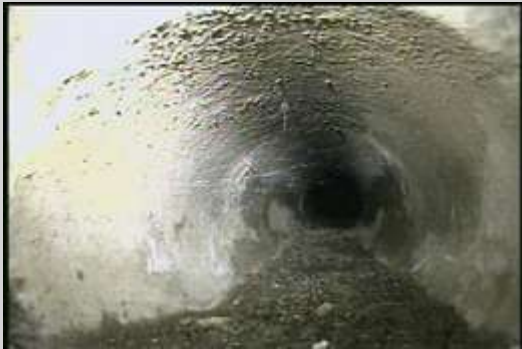
12 O'Clock Outflow

4 in. Circular Gravity Sewer
Pipe Out @ 12 O'Clock

Deposits: ☐ None ☐ Mud ☐ Sludge ☒ **Debris** ☐ Grease

Silt Depth: 1 (in.) Deposits Extent: **Light**

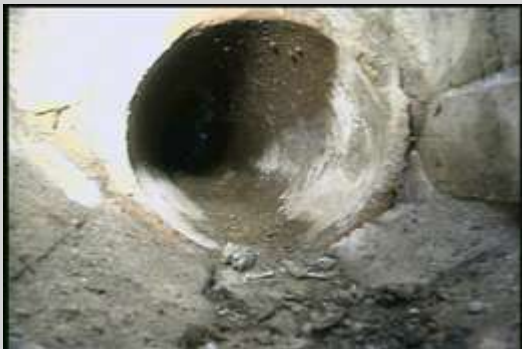
3 O'Clock Inflow

4 in. Circular Gravity Sewer
Pipe In @ 3 O'Clock
